PROGRESSIVE COLLAPSE TESTING AND ANALYSIS OF A STEEL BUILDING

HONORS THESIS

This research investigates the progressive collapse vulnerability of an existing steel building, Haskett Hall, on the Ohio State University (OSU) campus. The building was tested by removing one of the first-story columns to observe its collapse resistance and to evaluate the effectiveness of current modeling and analysis guidelines. Progressive collapse is a partial or complete collapse of a structure due to the loss of a supporting element, a column in this case. Few researchers have been able to conduct full-scale experiments to understand the progressive collapse mechanism. One previous OSU study tested the vulnerability for progressive collapse of a steel building in Northbrook, Illinois, and another building on the OSU campus. It was concluded that more detailed models are needed to account for nonlinearity, three-dimensional and dynamic effects in analysis of a building frame including beams and columns surrounding the removed column. To address these issues, in this research deflections and deformations within the neighboring beams and columns were measured during column removal. A structural analy

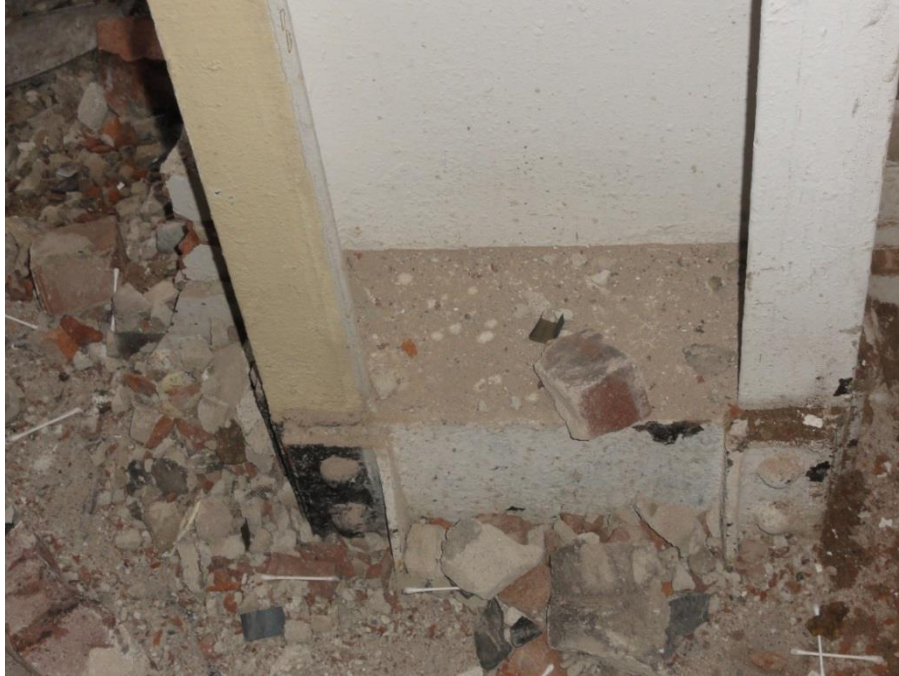
Figure 2.10: Rigid column footing

The first floor columns were connected rigidly to the ground with rivets and angles (Figure 2.10). Typical footing for columns were designed with #6 bars that ran parallel and perpendicular to each other to create a square base (Figure A.12). At edges, bars were bent up to be hooked. Select columns extended its footing to create trapezoidal cross-sections (Figure 2.11).

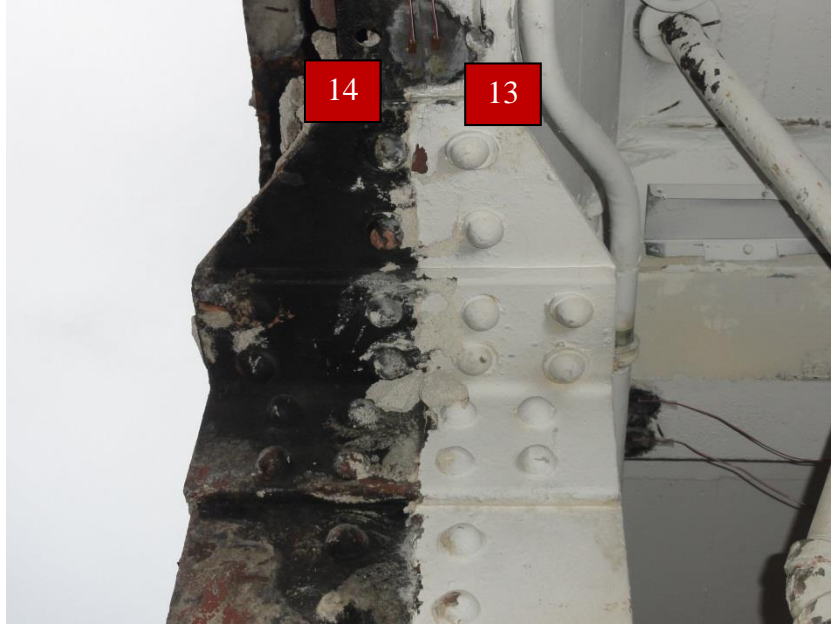
Figure 3.7: South-directed beam instrumented with strain gauges #13 and #14

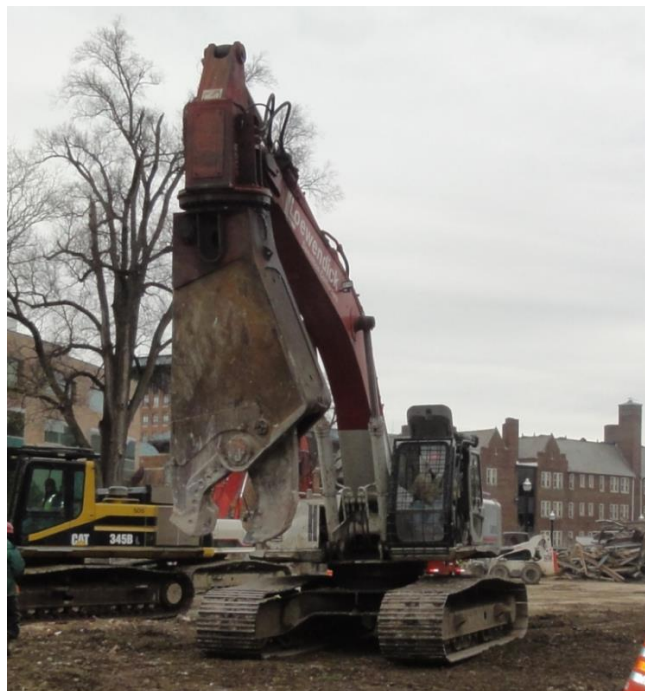
Figure 3.12: Loewendick Demolition Company's processor used to cut the column

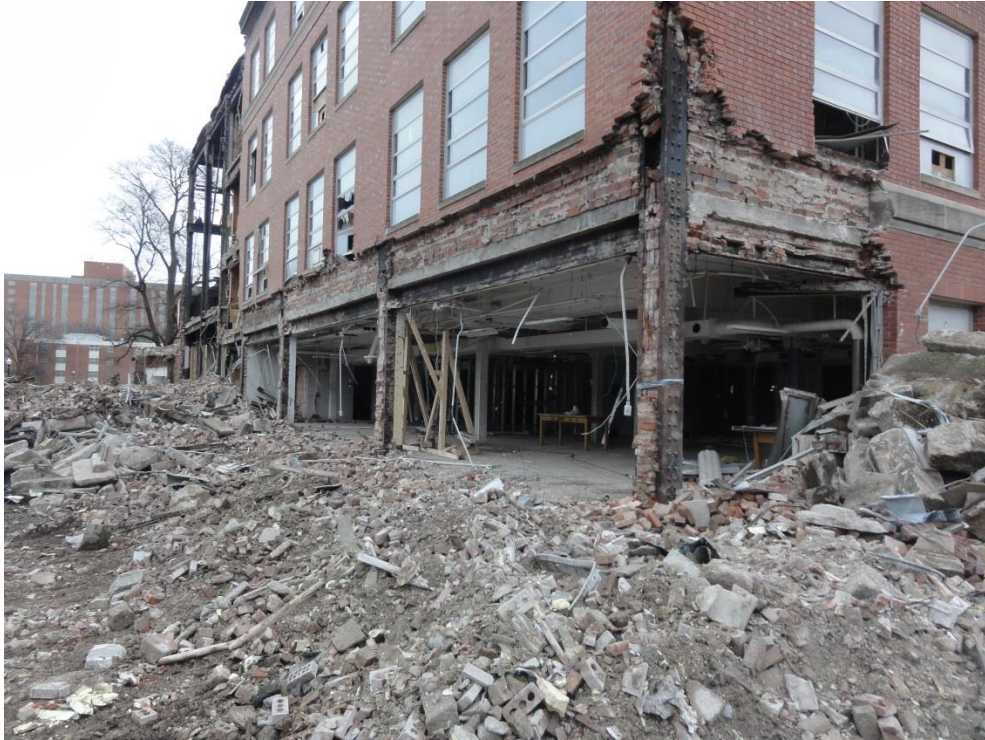
Figure 5.1: Partially removed Western façade to expose the frame

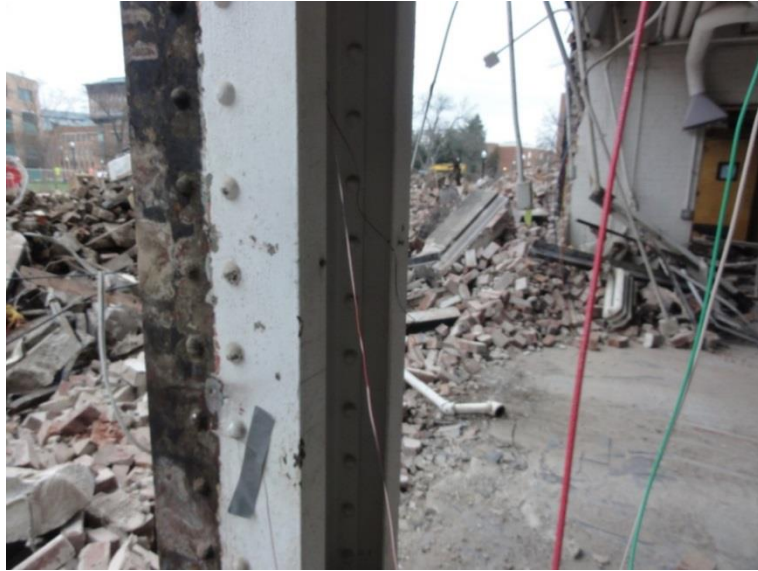
Figure B.1.3: North column 26 seen from Southeast-direction. Used to estimate base flange length

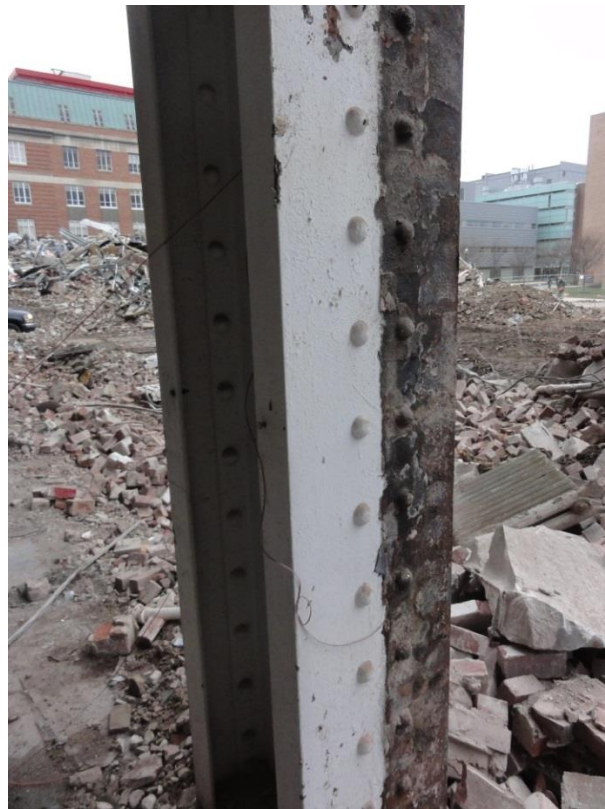
Figure B.1.4: North column 26 seen from Northeast-direction. Used to estimate I-section base flange length and channel flange thickness

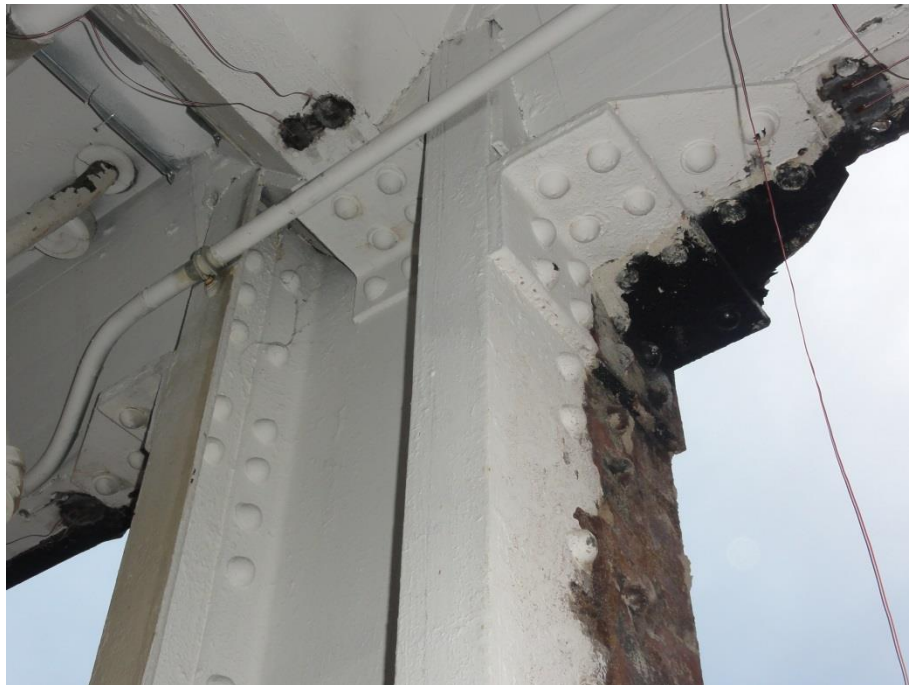
Figure B.2.4: Removed column 27 seen from Northeast-direction. Used to estimate I-section base flange length and channel flange thickness

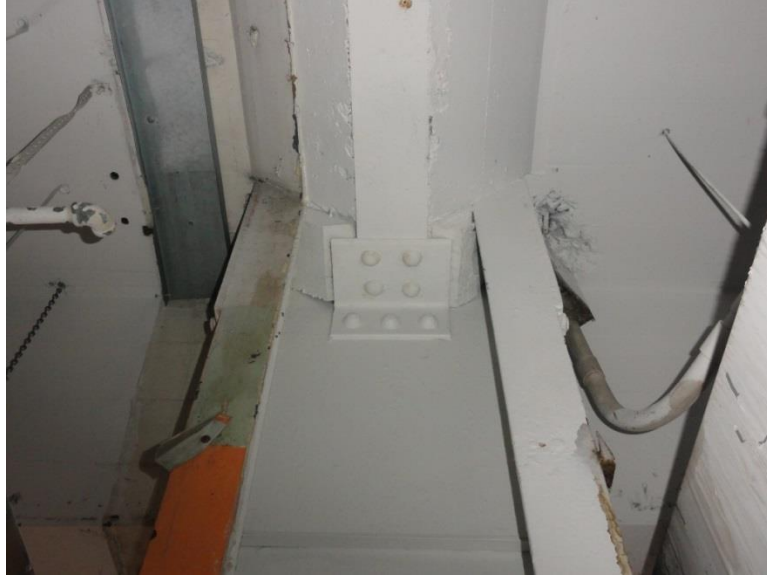
Figure B.3.1: East column 28 seen from East-direction. Used to estimate overall depth and channel flange length

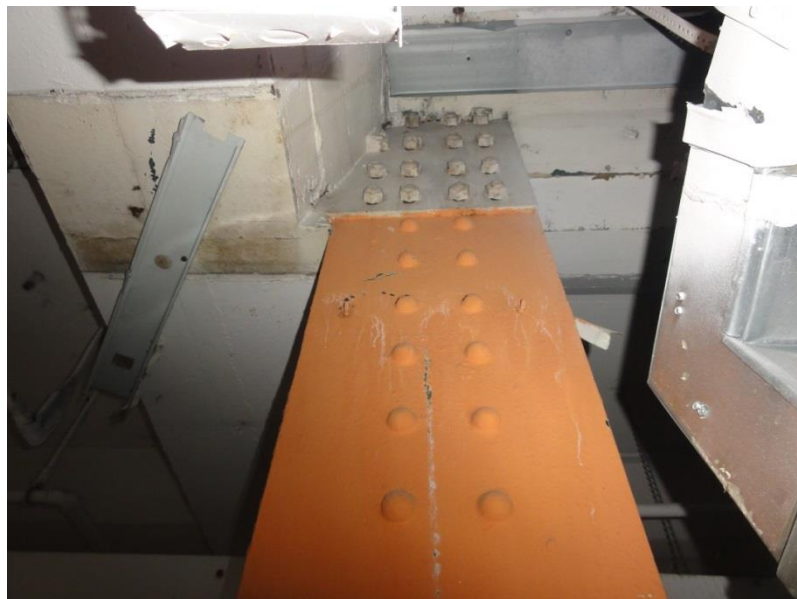
Figure B.3.2: East column 28 seen from East-direction. Used to estimate bracketing channel depth

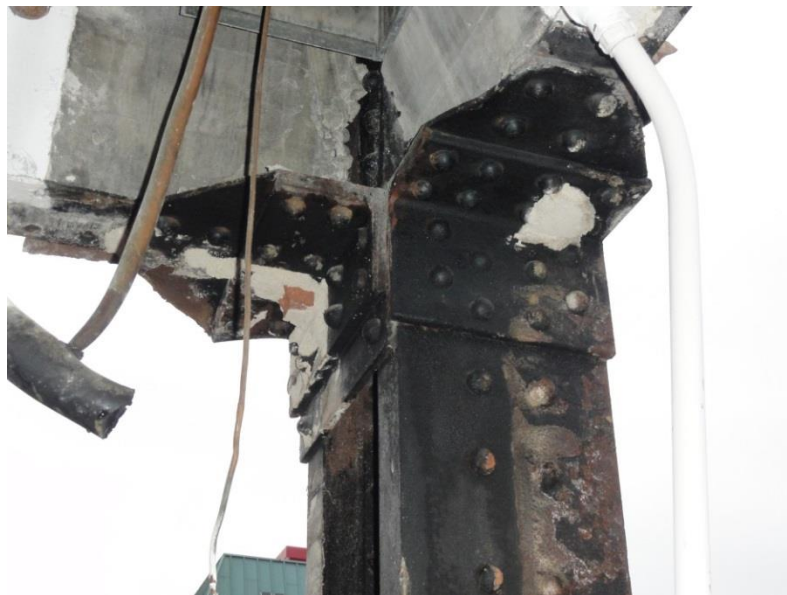
Figure B.4.2: South Column 38 seen from Northeast-direction. Used to estimate channel thickness and show beam partial concrete reinforcement

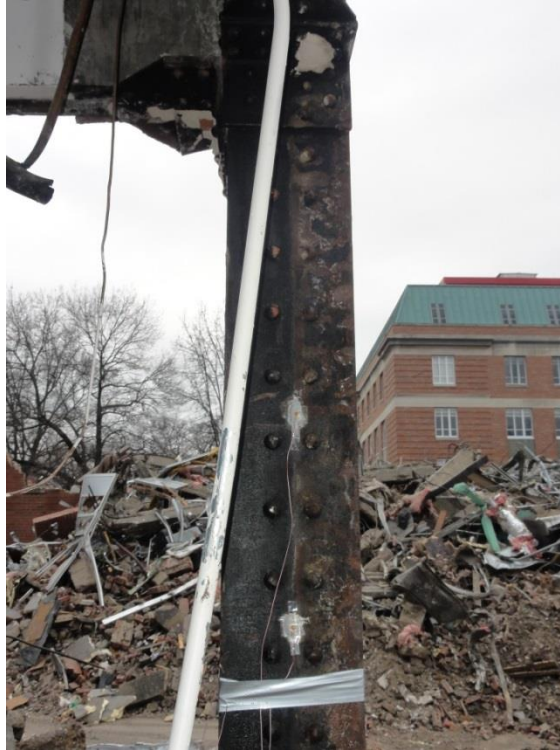
Figure B.4.3: South column 38 seen from North-direction. Used to estimate bracketing channel depth

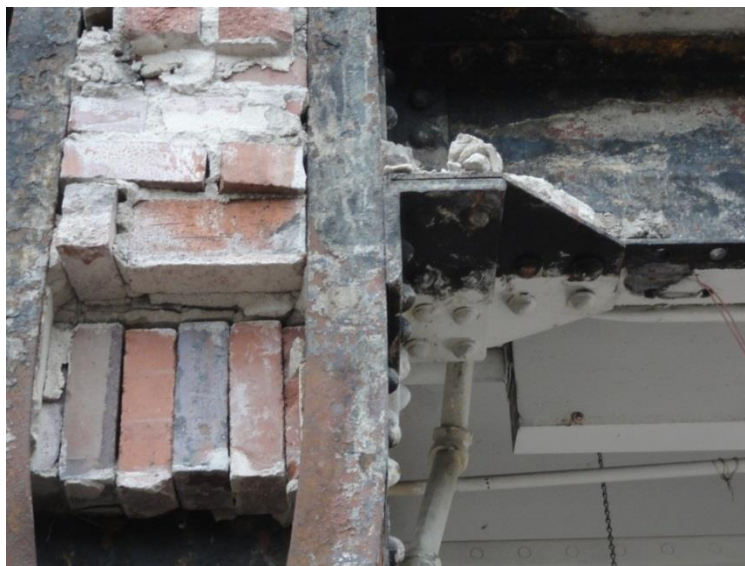
Figure B.5.1: Beam-column connection with rivets through angles on beam bottom flange and web
